Asbestos and Lead-Based Paint Report  
Former Kathleen Mitchell Elementary School  
College Park, Fulton County, Georgia

May 7, 2020

## Asbestos and Lead-Based Paint Report

Date: May 7, 2020

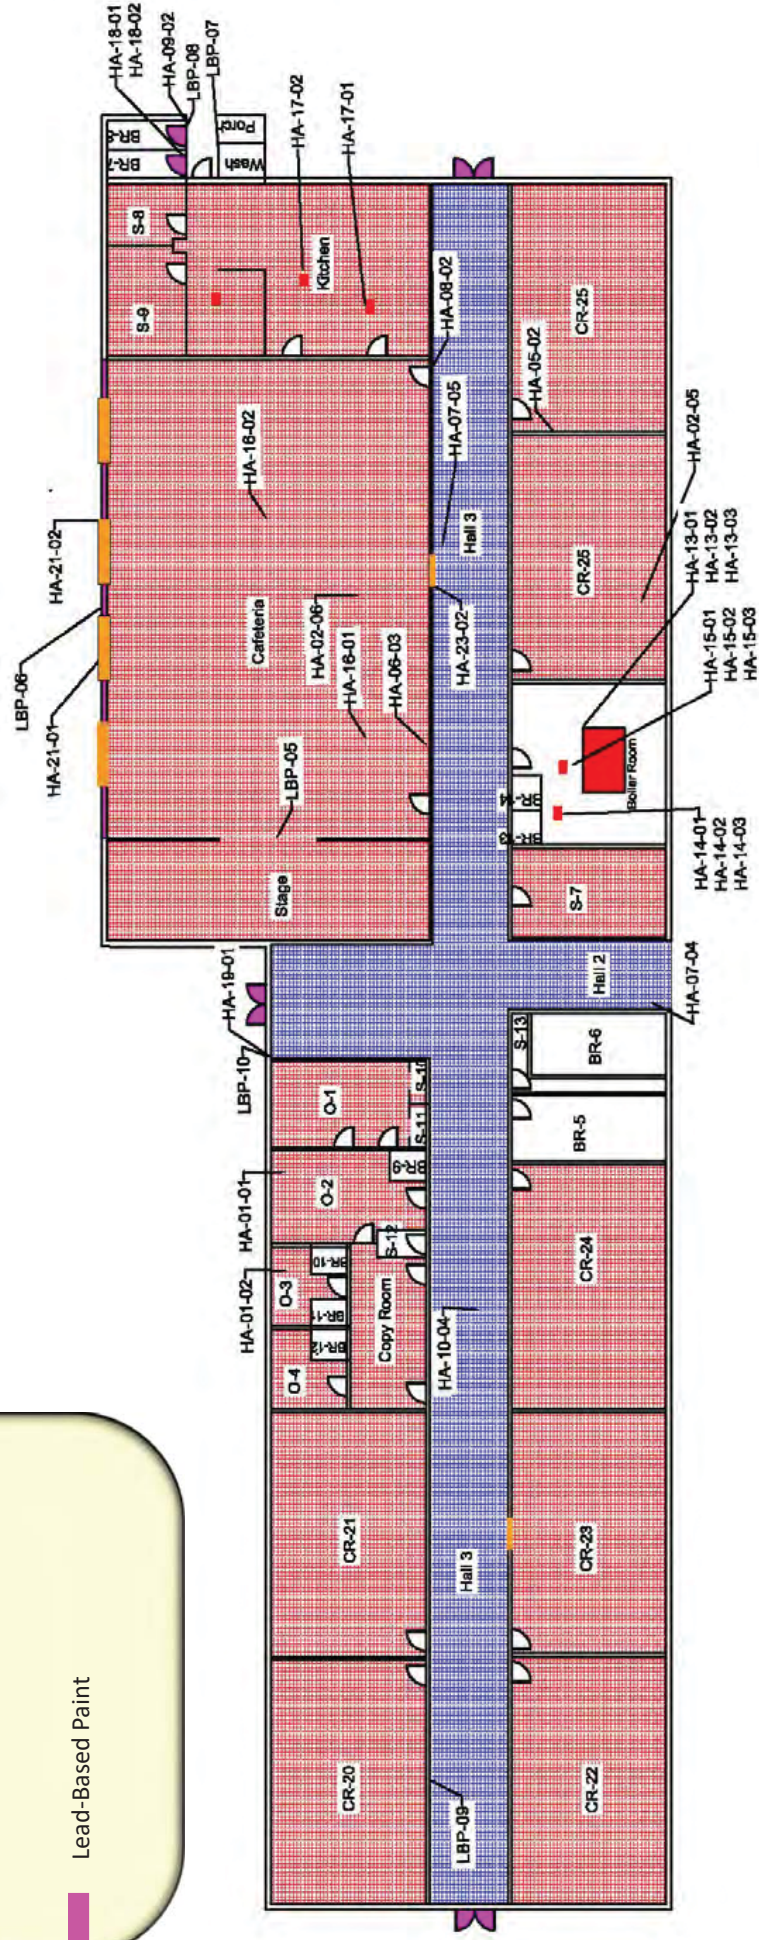
**Figure 3a**  
**North Section**  
**ACM / LBP Survey Location**

Location of identified asbestos containing joint compound, VFT, and black mastic
